## Rocky Flats Environmental Technology Site

### Reconnaissance Level Characterization Package for the Building 111 Cluster

September 2000

#### Revision 1

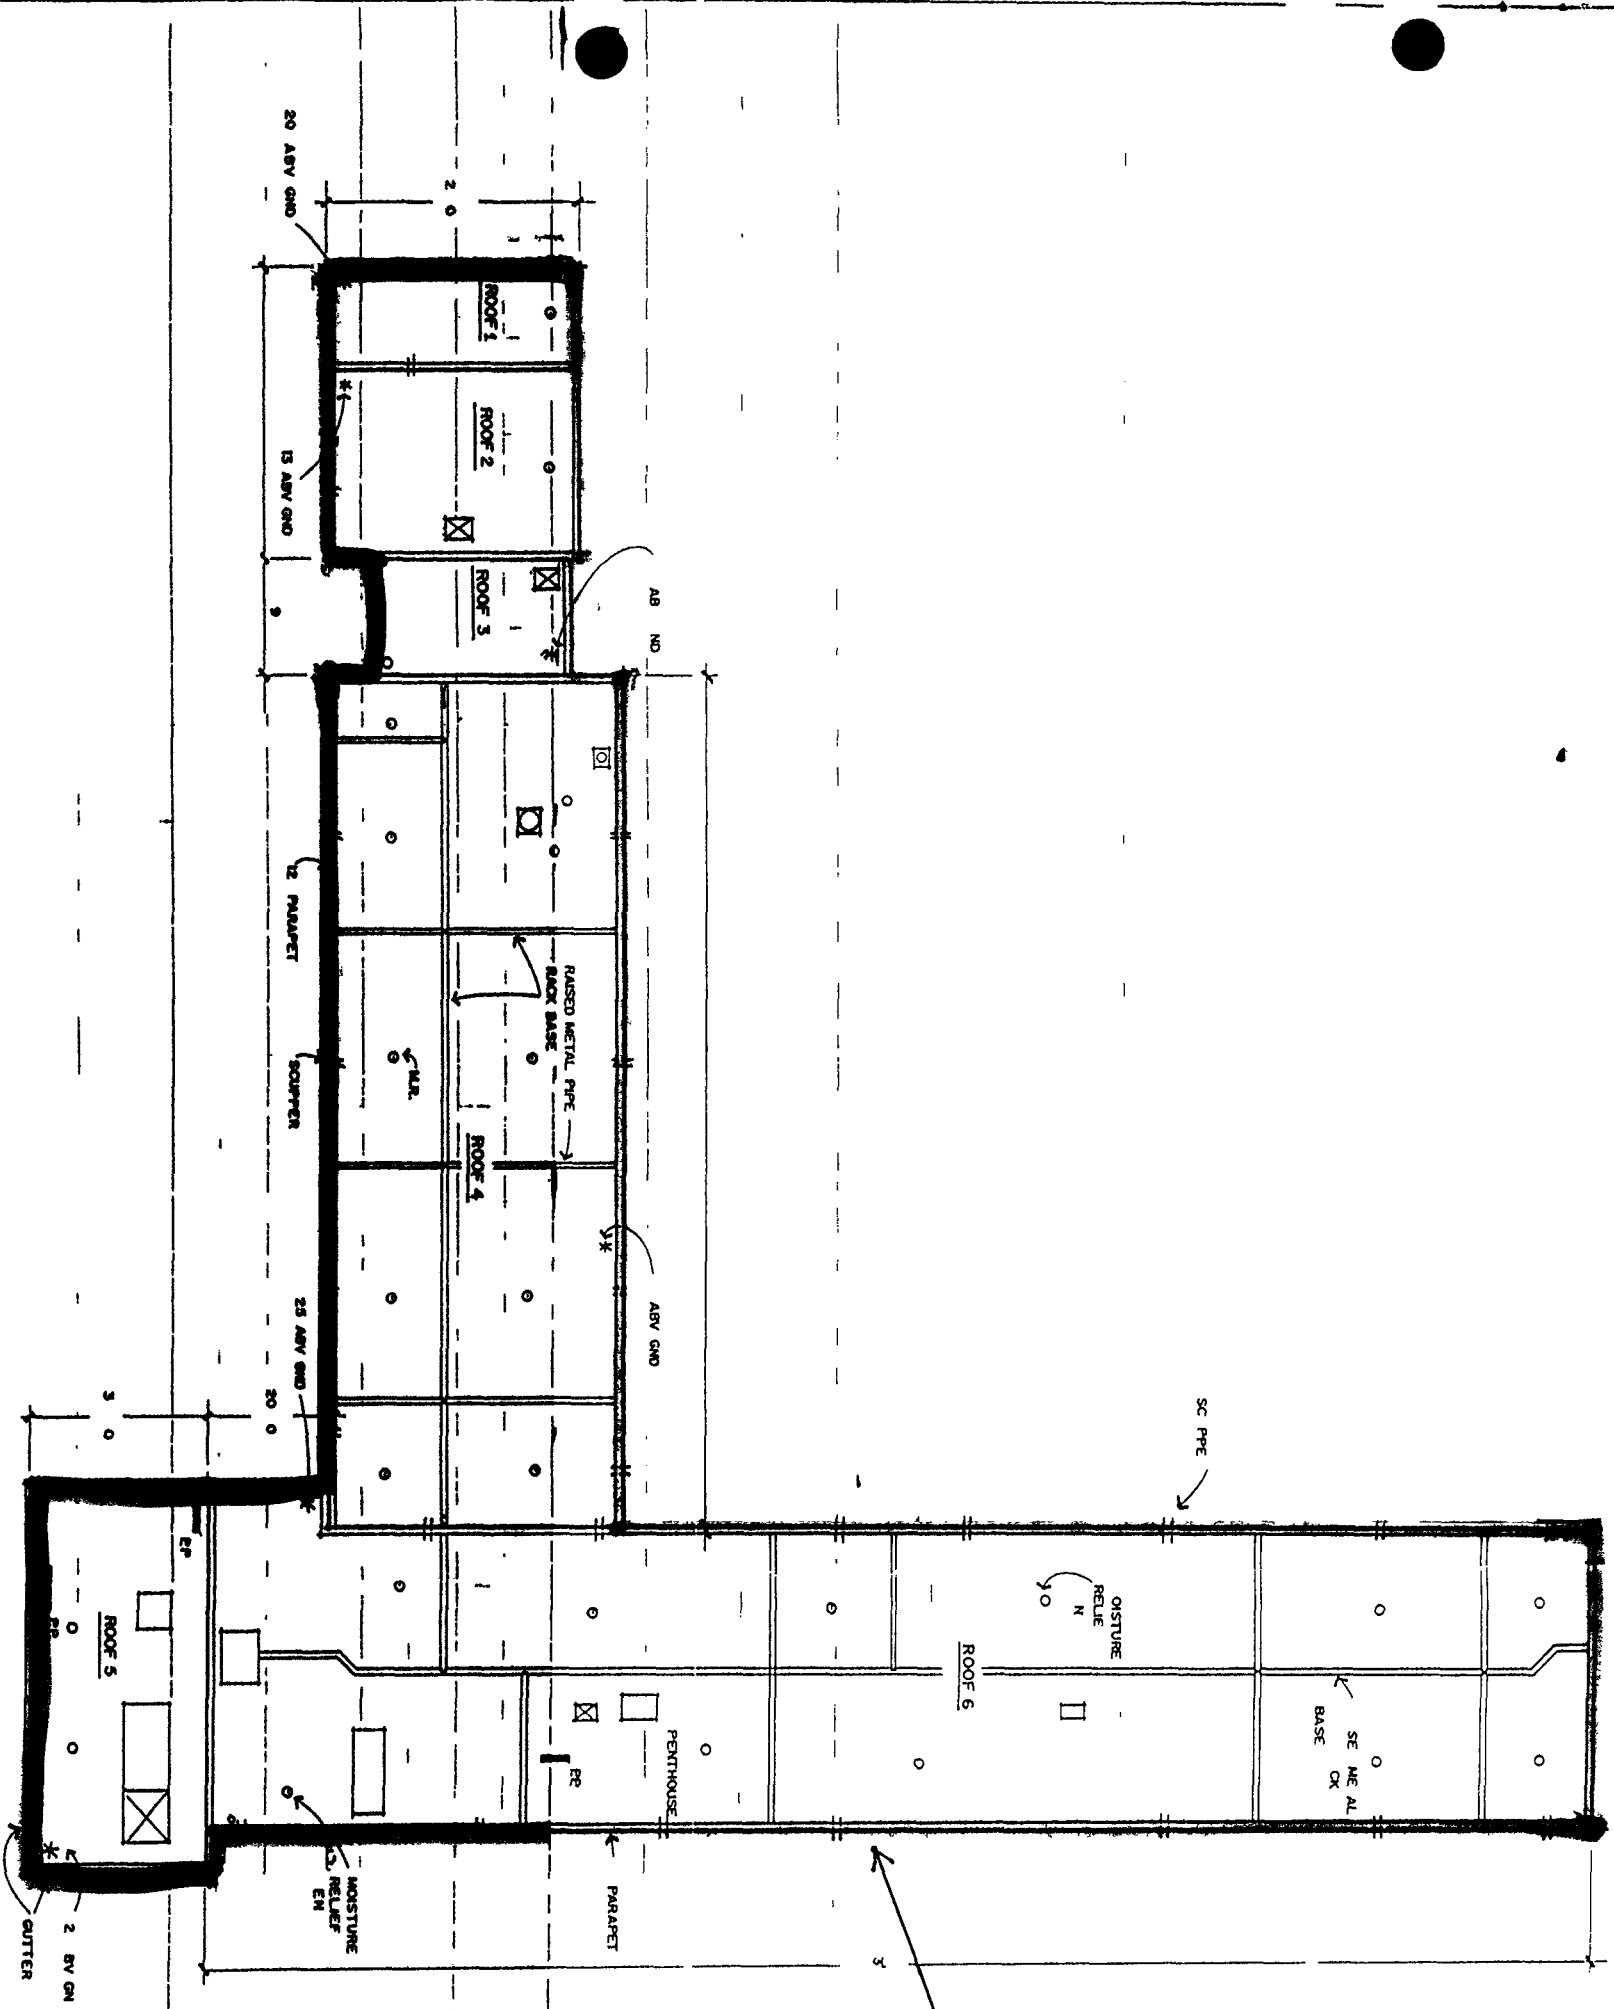
111-E-011

These survey areas are broken down further into 13 survey units based primarily on similar characteristics and contamination potentials. Survey unit designations are shown in the attached floor-plan maps (Attachments 1a, 1b & 1c) and are described in Table 3-1.

The only survey unit assessed for media sampling was the roof of B111. Review of B111 historical documents showed a total re-roofing occurred in the early 1970's. The original roofing consisted of butyl rubber covering over 1.5-inches of mineral-fiber insulation. As stated in the reviewed plan (RFETS DWG No. 19519-1, 19520-1 through 19520-5, and 19521-1 through 19521-5), "All roofing material and insulation, flashing, cants, etc. shall be removed from the roof." Therefore, any potentially impacted roofing material from RFETS historical releases (e.g., the 1969 fire) was removed and replaced with new materials. This information, combined with the Impacted Class 3 MARSSIM classification, precludes the need for surface media sampling.
